DOT/FAA/AR-96/21

Composite Failure Analysis Handbook Update 1

August 1997

Final Report

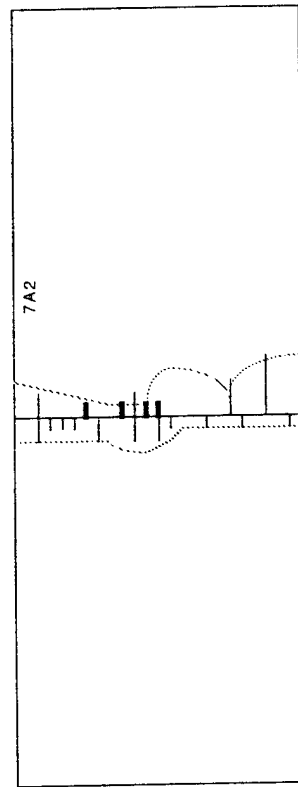
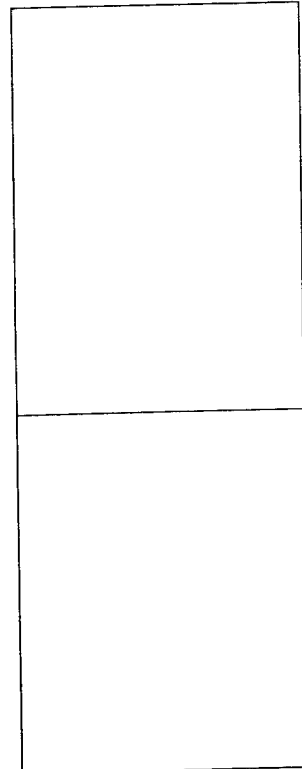
Figure 3.8-23. Improper Core Sample 7A2—2.4X Reduction

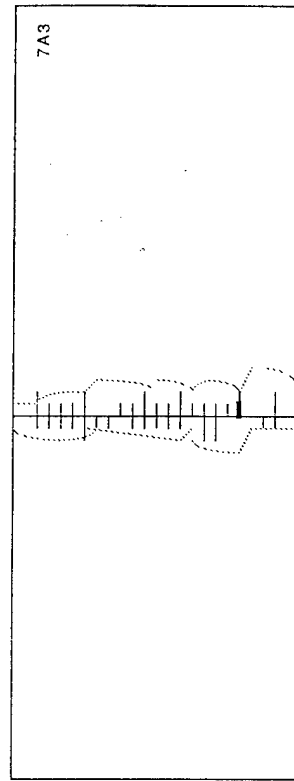
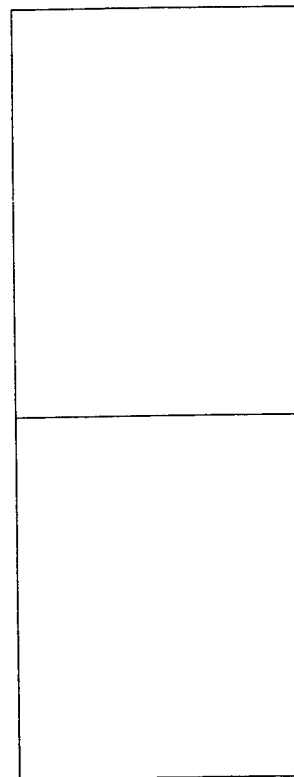
Figure 3.8-24. Improper Core Sample 7A3—2.4X Reduction

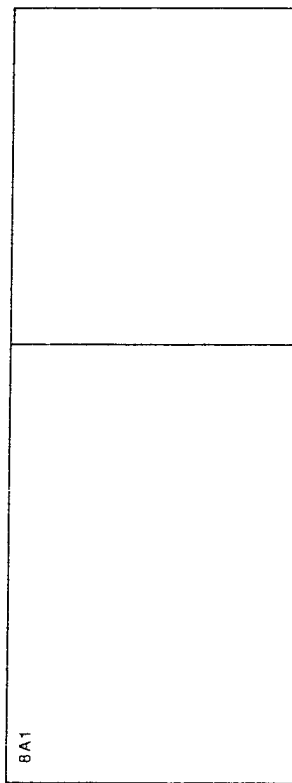
Figure 3.8-25. Undercured Adhesive Sample 8A1—2.4X Reduction

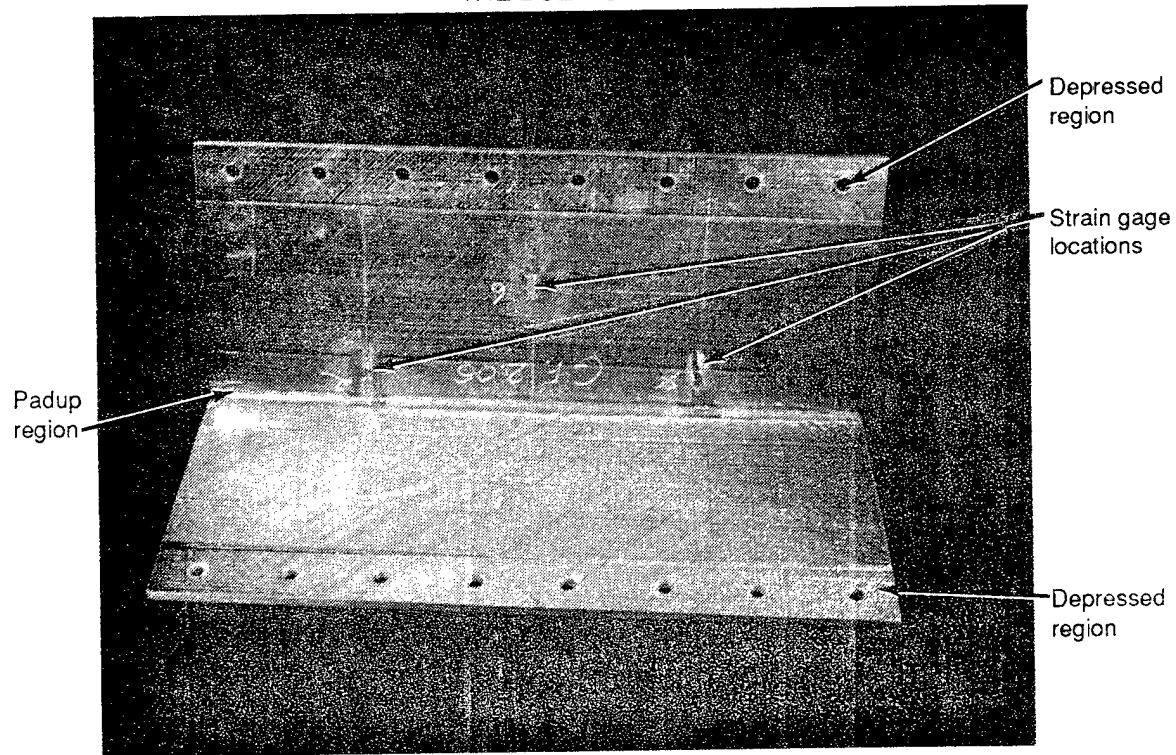
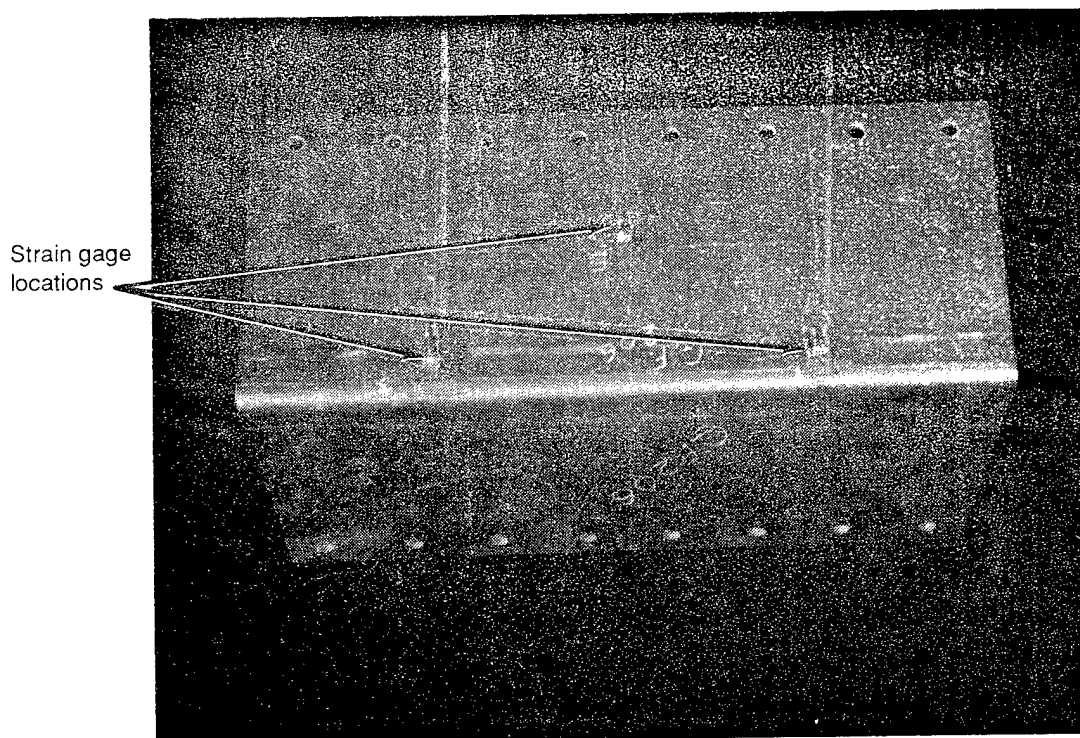
Figure 2. Photographs of the As-Received Component

The submitted component (shown in fig. 2) was approximately 14 inches long with 5-inch wide flanges. The thickness was approximately 0.17 to 0.20 inch. The angle between the two flanges was approximately 95 to 100 degrees. The overall color and appearance was indicative of a carbon fiber-reinforced plastic system.

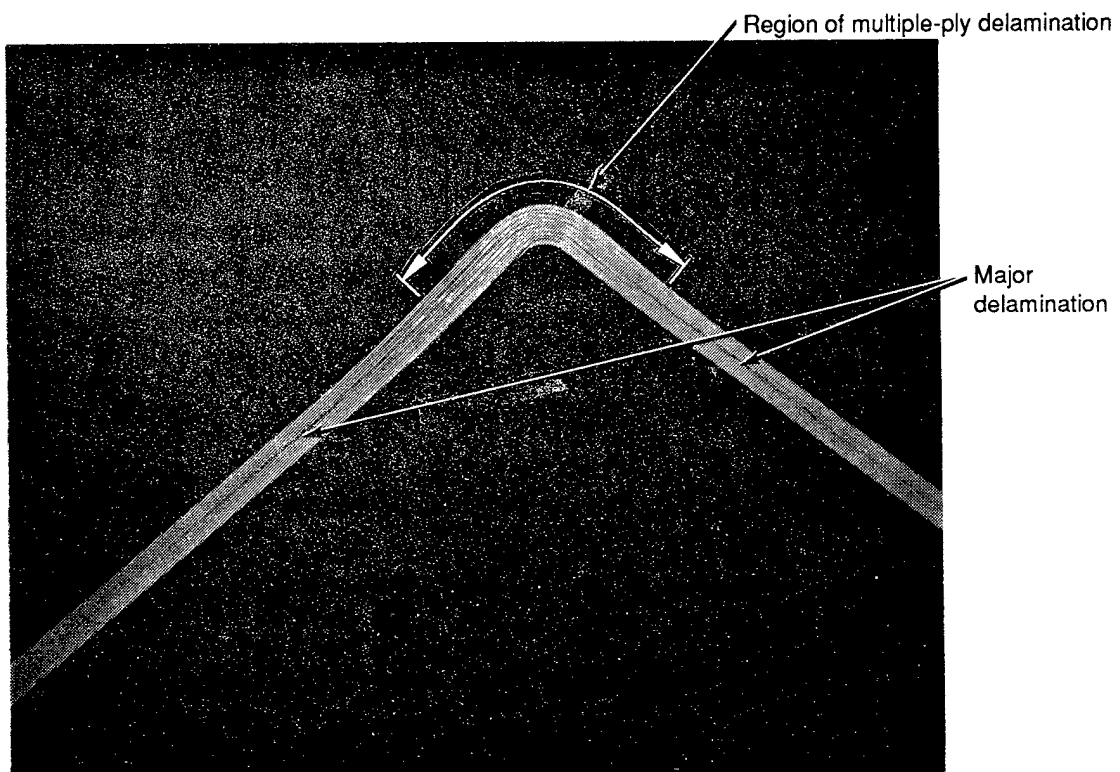
Figure 3. Photographs of the Edge of the Component Showing the Extent of Delamination

Internal delaminations, observe from both ends of the part, extended from the "knee" or angle region to the edges of the flanges (fig. 3). A 3-inch long delamination was located along the center plies. This delamination extended from an inserted ply placed within the center of the fiber plies at the knee region.

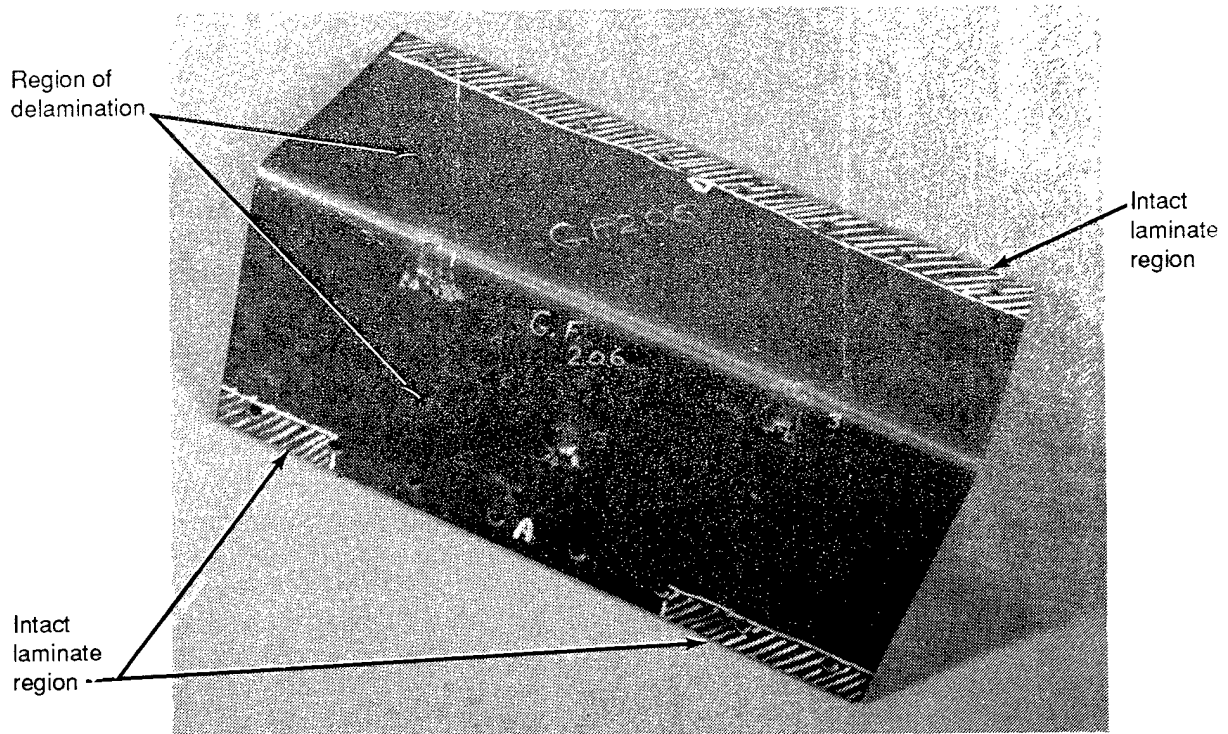
Figure 7. Photograph Showing the Regions of Intact Laminates Identified Using Pulse Echo

Examination using a handheld pulse-echo unit (C-scan) with a .25-inch transducer identified delaminations throughout the component (see fig. 7) except at certain locations along the region containing the fastener holes.

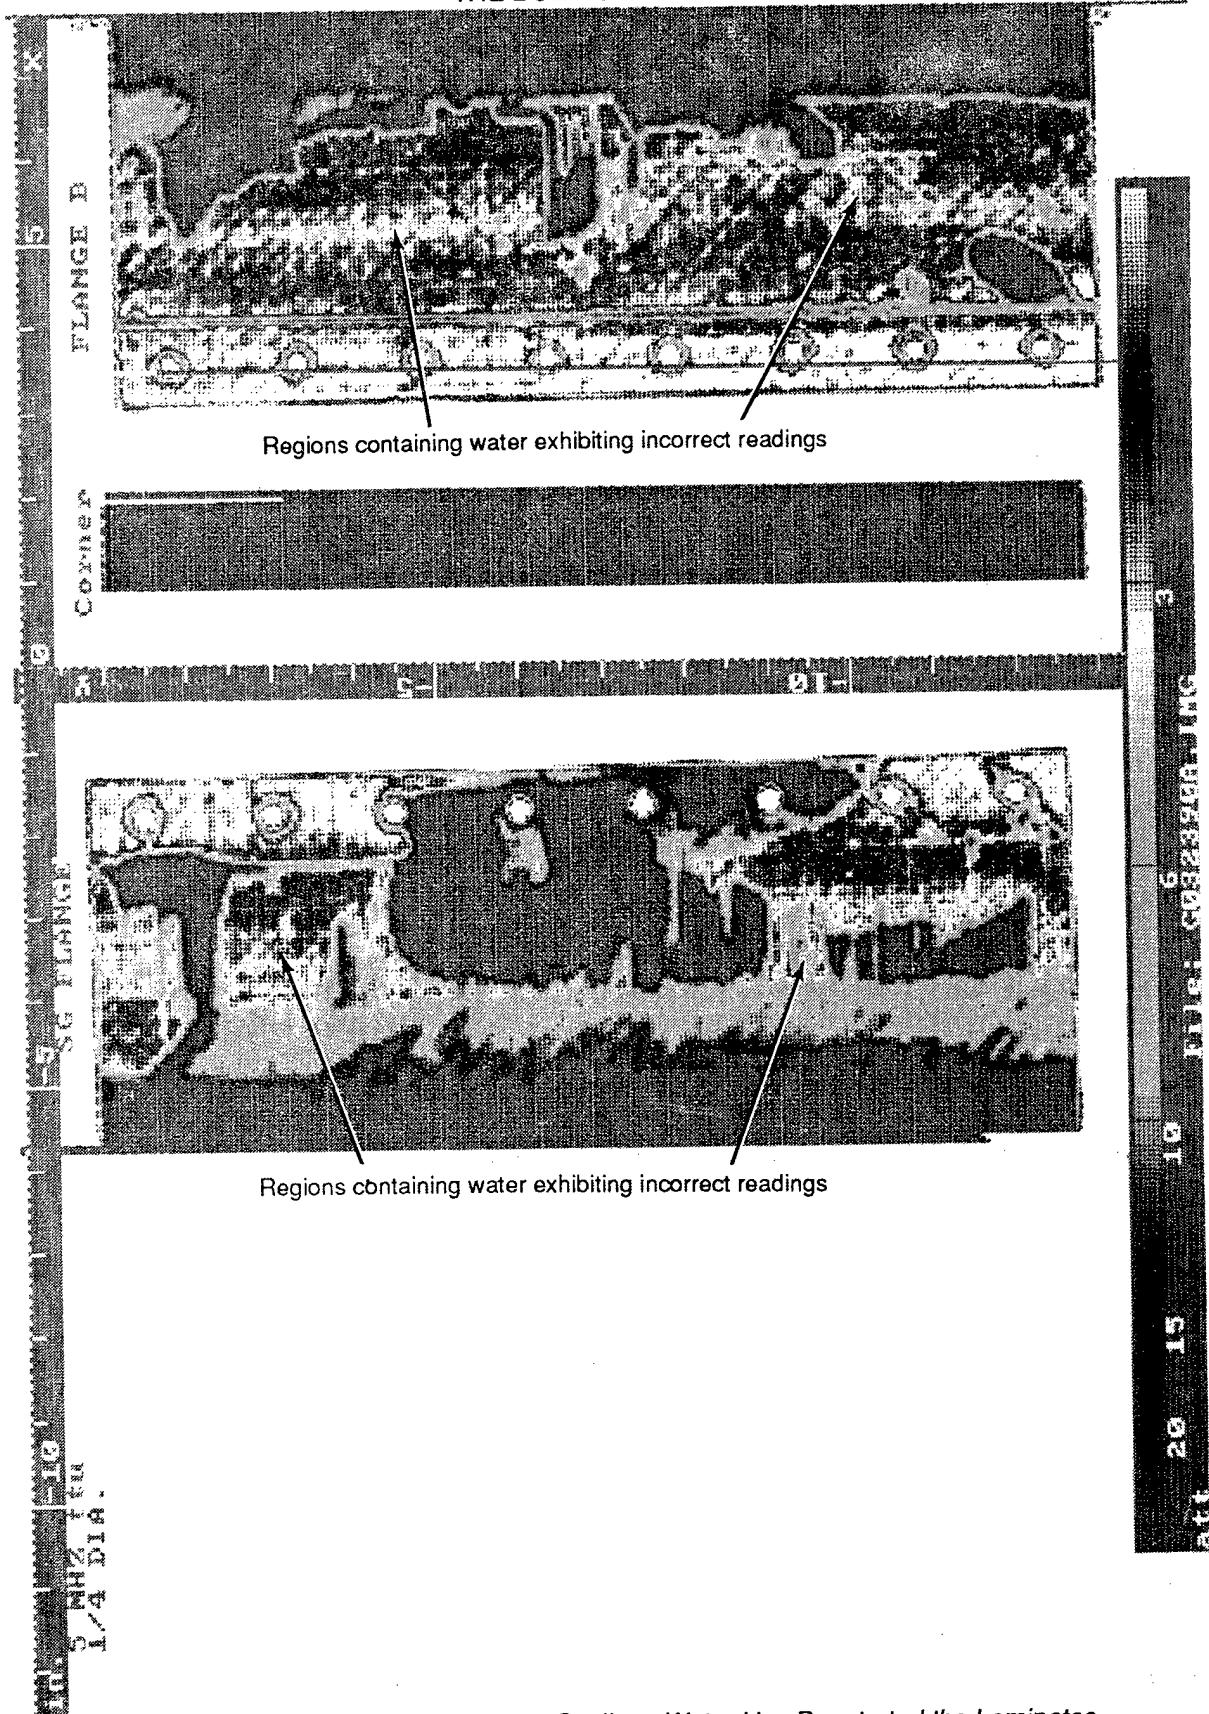
An attempt was made to further characterize the extent of delaminations using TTU (C-scan). However, since the part was exposed to water jets to perform the TTU analysis, large amounts of water entered the part through the edges and caused incorrect indications of delaminations and damage (fig. 8). These were grossly inconsistent with the pulse-echo analysis.

Figure 8. TTU Scan Before Sealing. Water Has Penetrated the Laminates From the Edges Causing Incorrect Readings

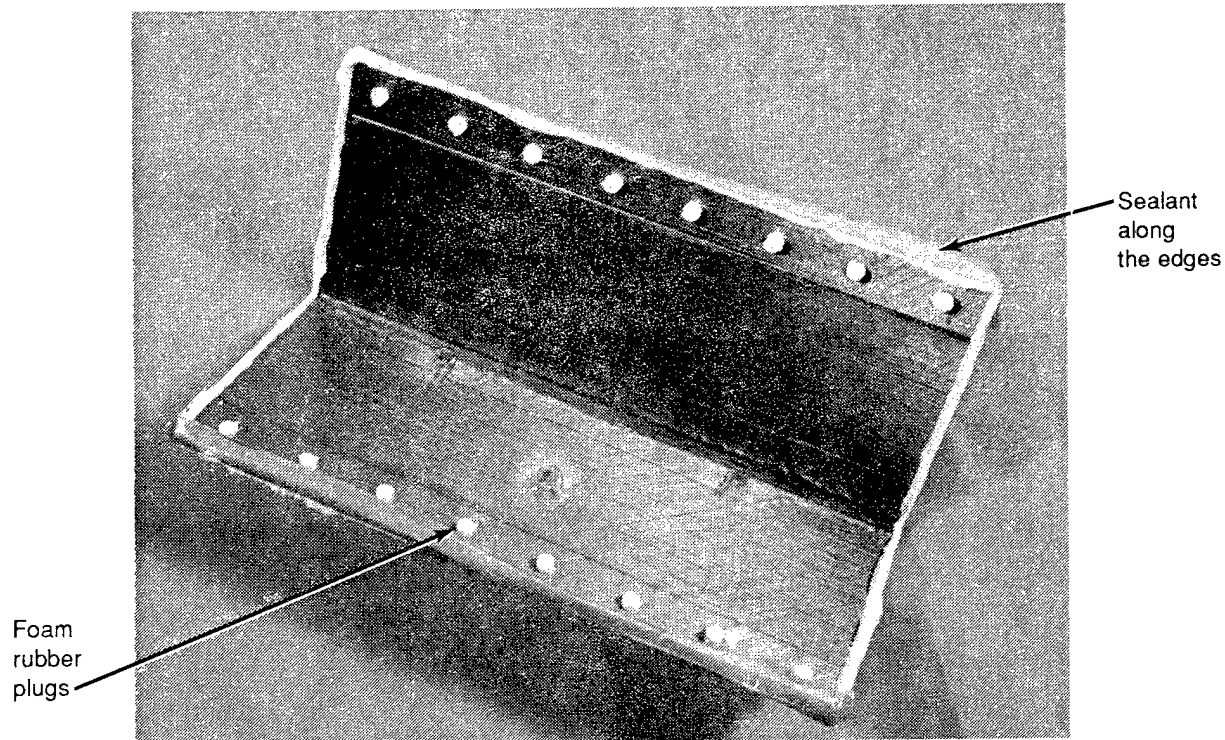
Figure 9. Photograph of the Part After the Edges and Fastener Holes Were Sealed Before the Second Series of TTU Scans

The part was subsequently dried in an oven at 90°F for 30 minutes before another set of scans was performed. This time the edges were sealed, the surface of the part was sprayed with a lacquer, and the fastener holes were plugged (fig 9). The part was then rescanned which revealed that it was almost completely delaminated (fig. 10). The grip areas were not delaminated as observed in the pulse-echo analysis.

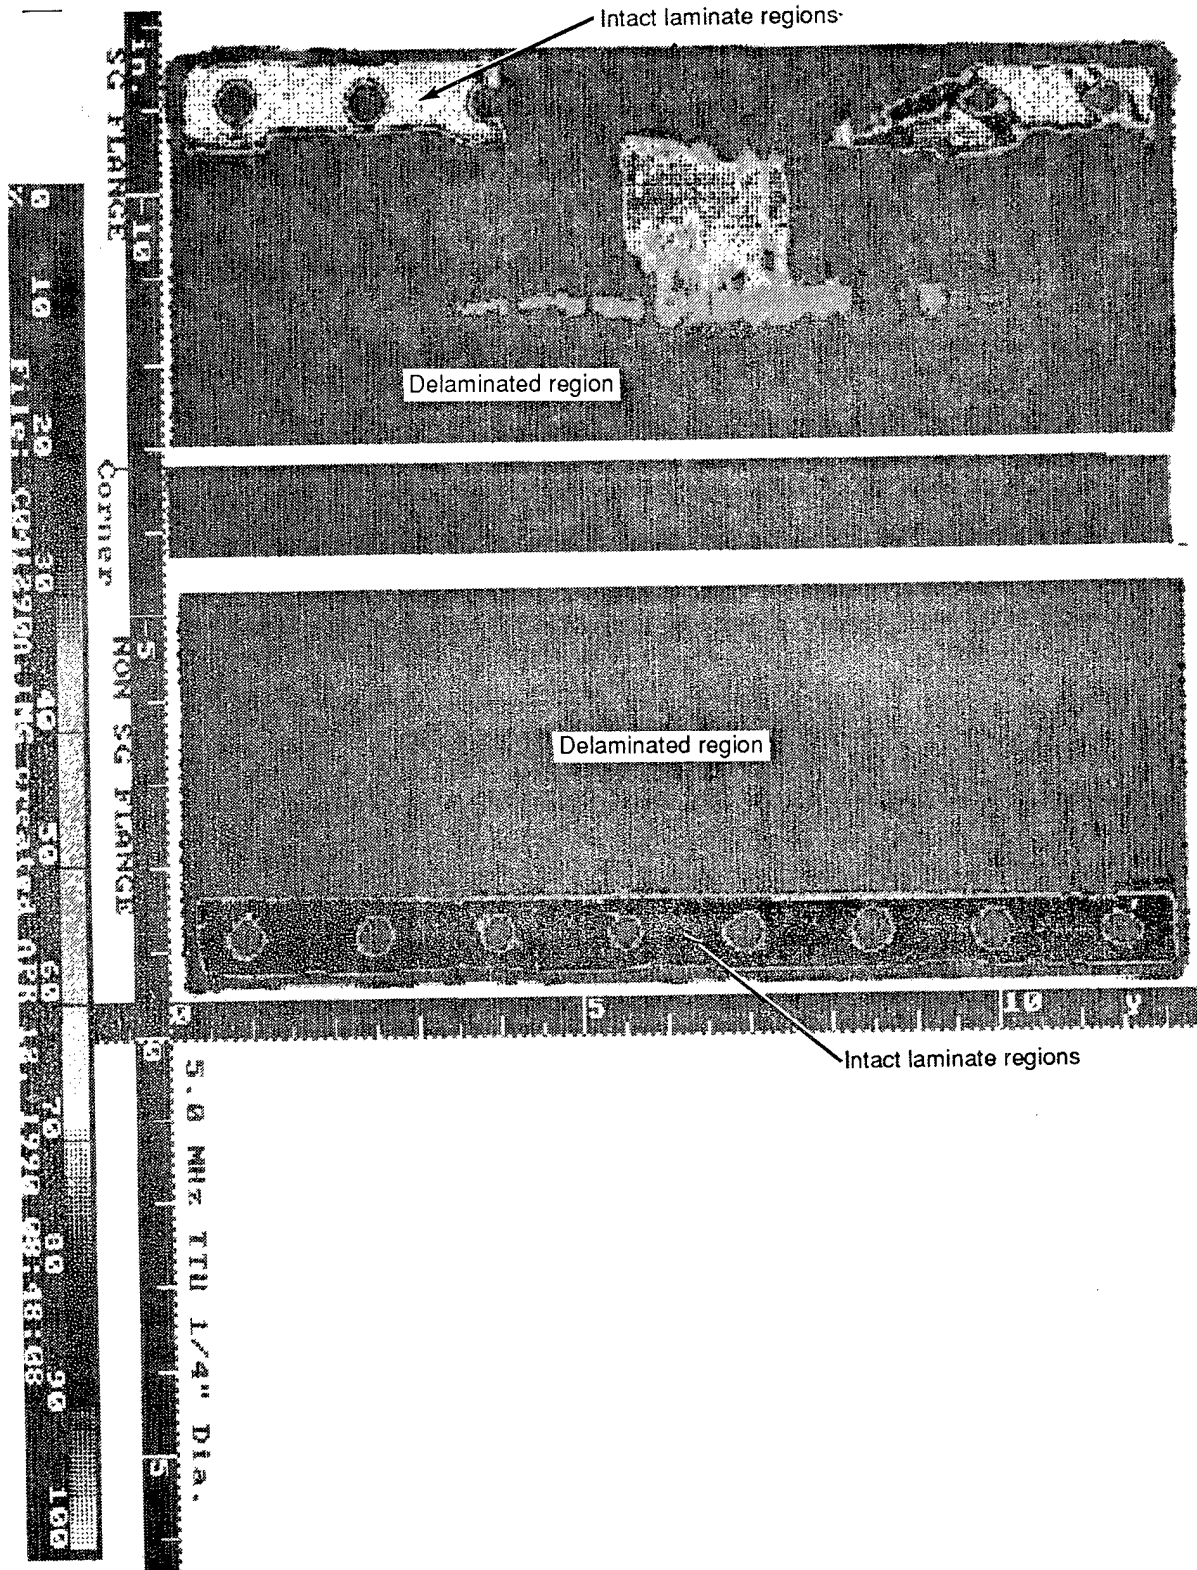
Figure 10. TTU Scan, After Drying and Sealing the Component, Exhibiting Delamination Regions Similar to the Pulse-Echo Examination

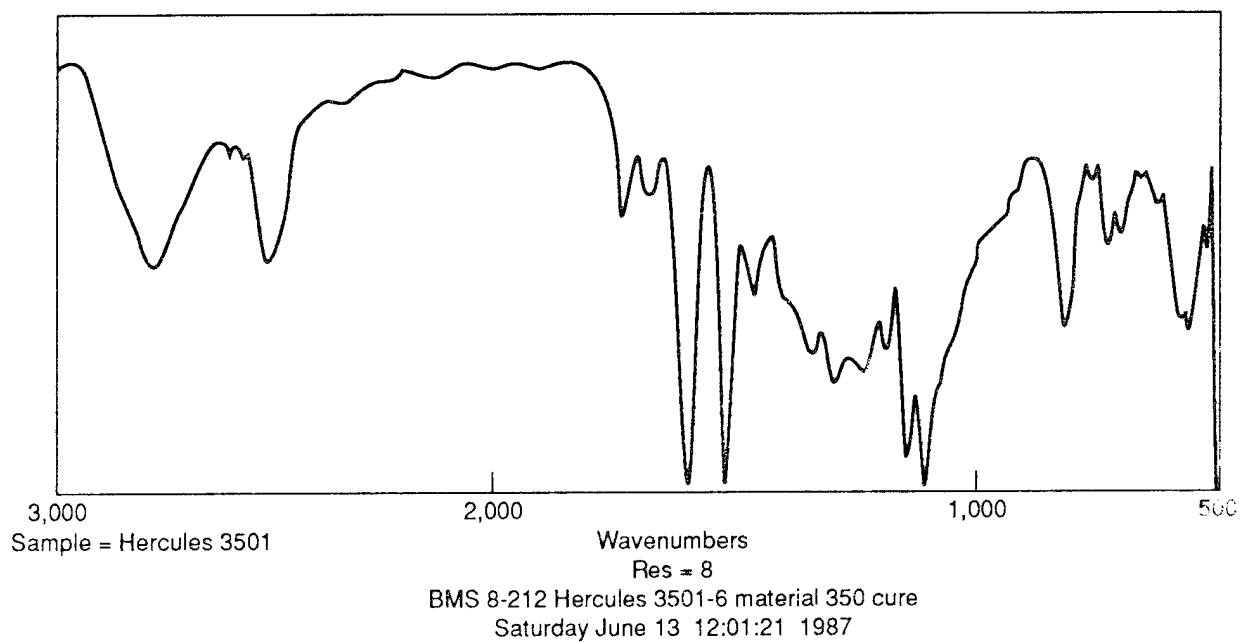
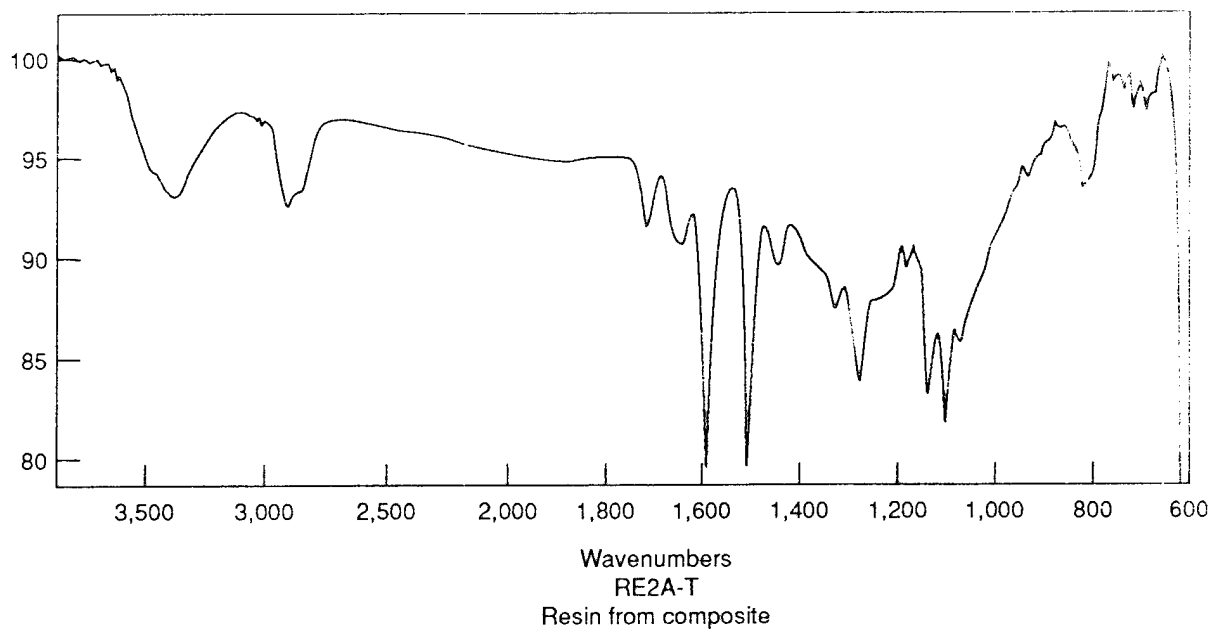
The resin material was examined using infrared spectroscopy analysis (IR). This identified the material as similar to the Hercules 3501-6 epoxy resin system (figs. 11 and 12). This material has a curing temperature of 350°F. IR also identified the peel ply material to be a Teflon/Fiberglass film.

Figure 11. IR Spectrum From a Sample of Hercules 3501-6 350°F Cure Epoxy Resin

Figure 12. IR Spectrum From a Sample of the Resin From the Component

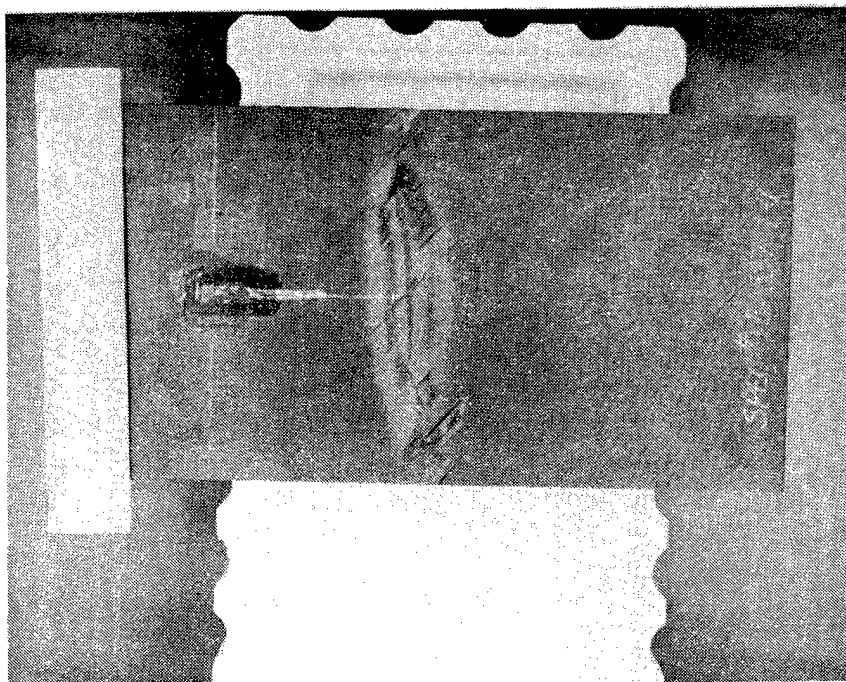
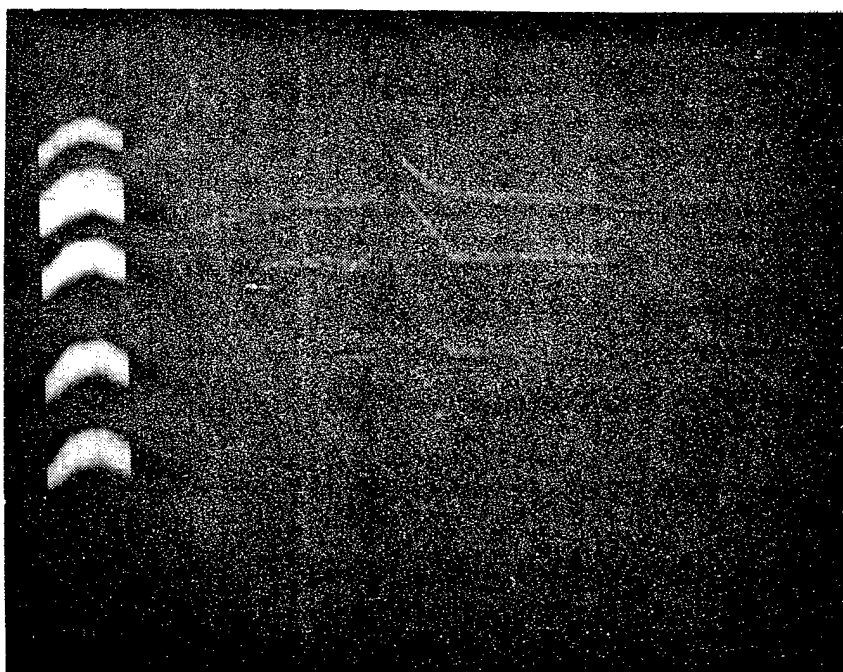
Following the visual examination, the surface of the component was analyzed using slit illumination photography. This technique involves photographing a series of beams of light projected at an angle onto the panel (Figures 4 & 5). Variations in the surface are seen as curvatures of the slit of light which have been calibrated to correspond to the variations in depth and height of the surface. This allows for quantitative documentation of the surface deformation as shown in Figure 6. Examination of the data reveals that the entire back side of the panel was warped. This is shown as both in a twisting and buckling type of deformation. It also indicates that no region of the panel was undamaged.

Figure 4. Buckled Surface Showing the Angled Slit Lighting Contours

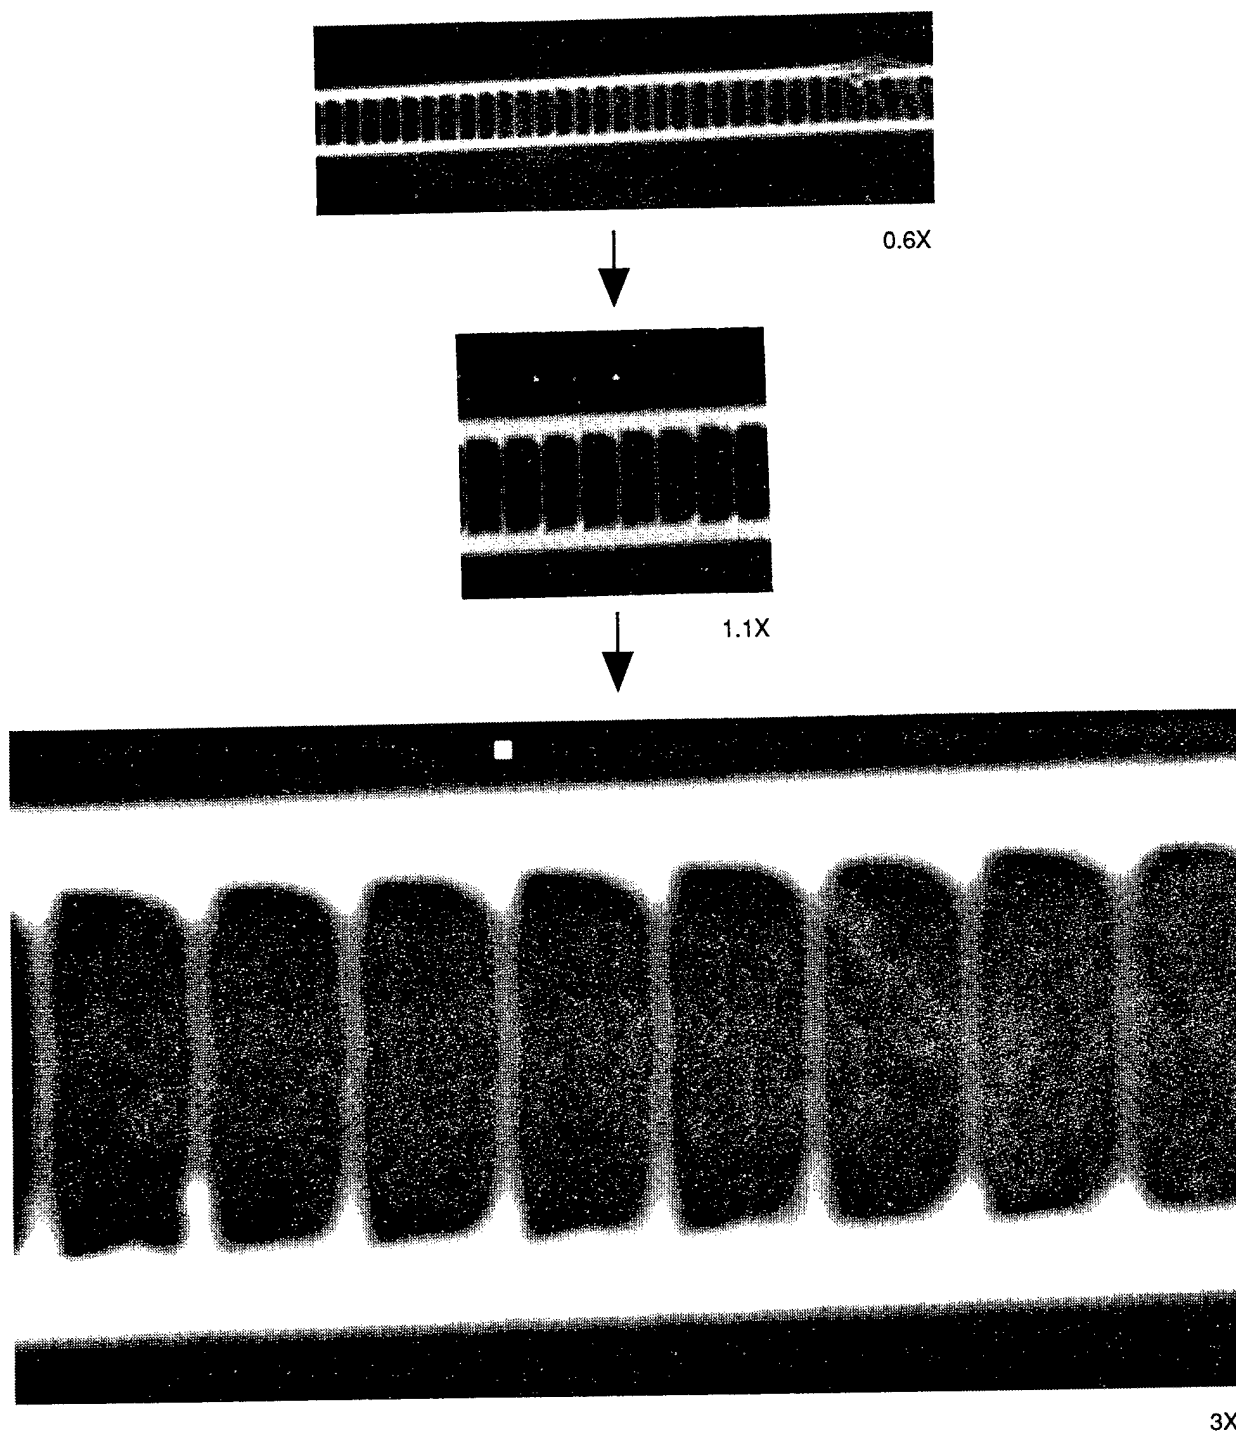
Figure 9. CT Images of the First Longitudinal Scan

Figures 8 through 11 through show the various images of the slices through the component. The longitudinal slices 1, 2, & 3 show the damage present in the honeycomb regions in the center of the component. The front half of the panel appears to have been crushed by a macroscopic shearing of the upper front half of the facesheet. The back half exhibited little if no damage. However near the bulge, the core appeared to be crushed in the short transverse direction. There was no evidence showing any longitudinal buckling trends to either end (from one end to the other). This transverse damage was located all along the back half of the component.

In addition, there was no evidence indicating that any honeycomb/adhesive failures occurred. All of the fractures in the core were located in the middle of the cell walls. This result is similar to the optical examination on the exposed edges of the panel.

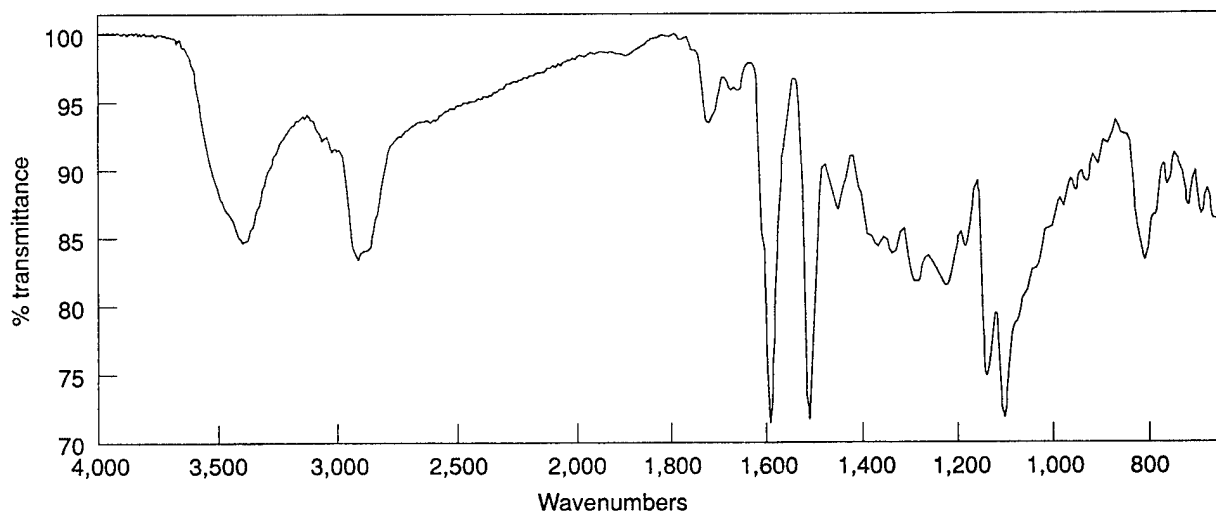
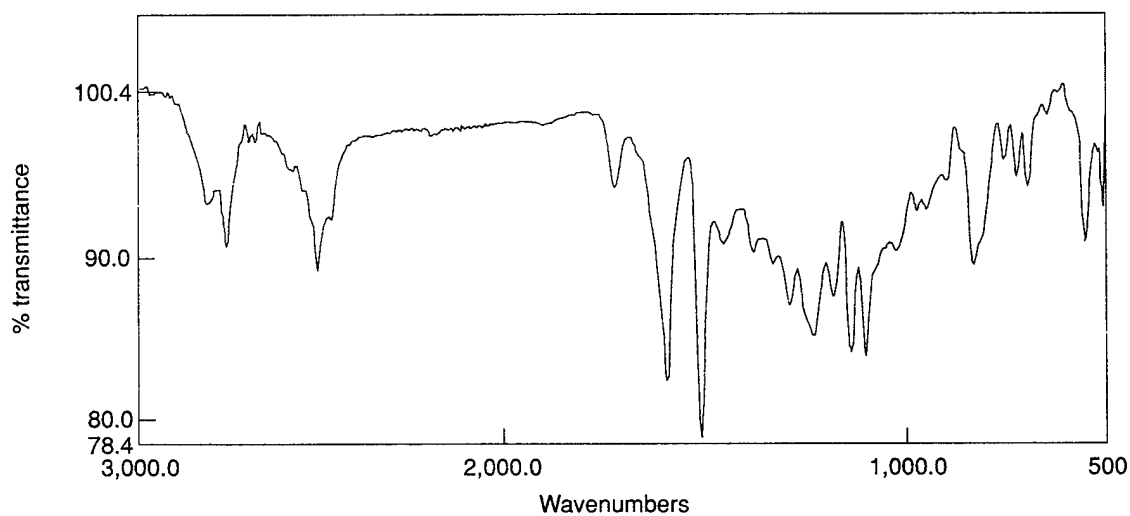
Figure 12. FTIR Plots of the, (a) Resin From the Honeycomb Panel, and (b) From a Data File of Hercules 3501-6

The facesheets were composed of carbon fibers in a 350° F cure epoxy resin system similar to the Hercules 3501-6 resin (see Figure 12). DSC analysis of the resin system revealed that the resin was fully cured (as shown in Figure 13a).

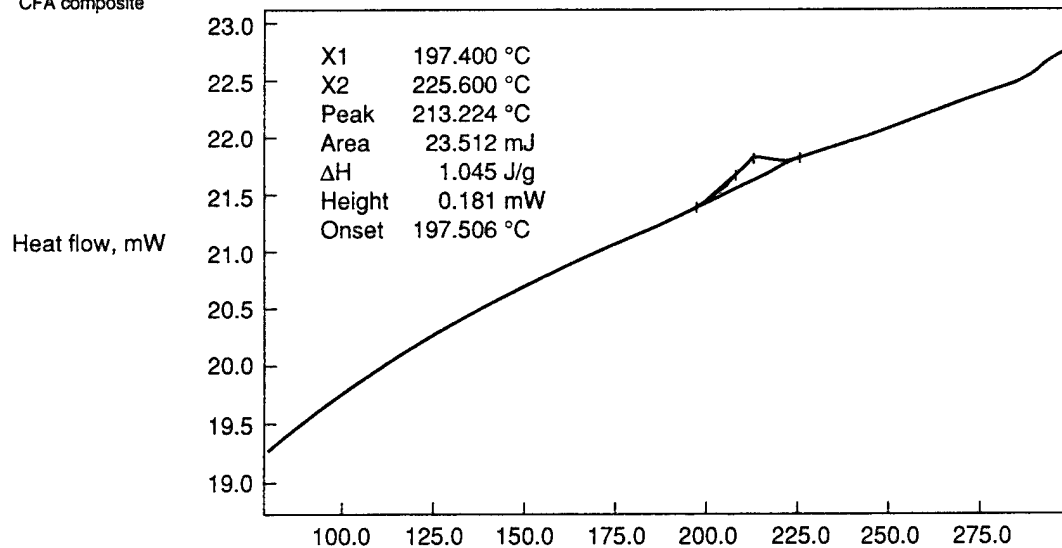
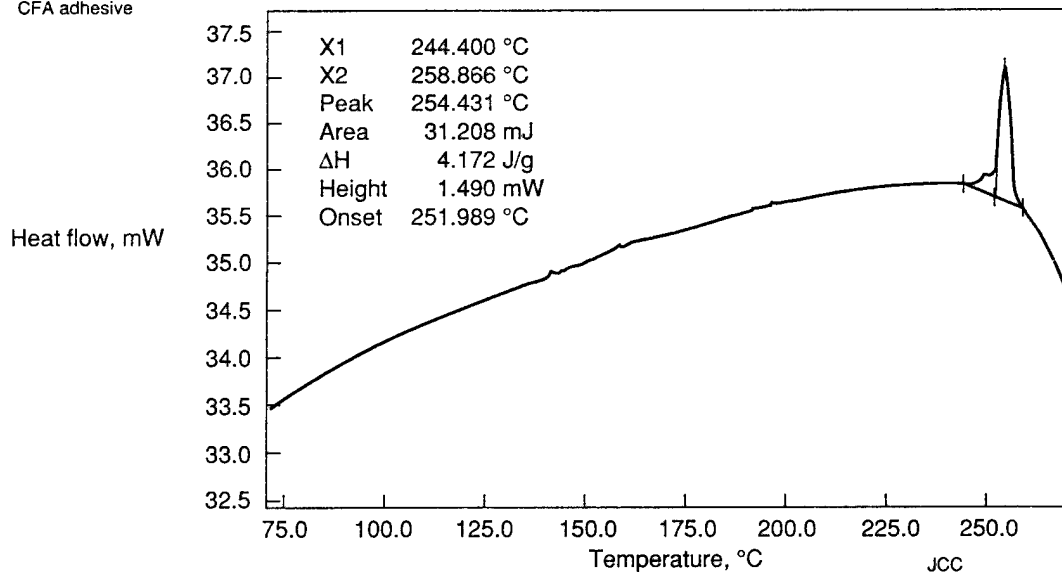
Figure 13. DSC Plots of the (a) Composite and (b) the Adhesive

The adhesive was identified as an epoxy with additional compounds (Figure 13b). DSC plots revealed an endotherm peak which was determined to be the result of melting. Further analysis indicated that the adhesive was fully cured.

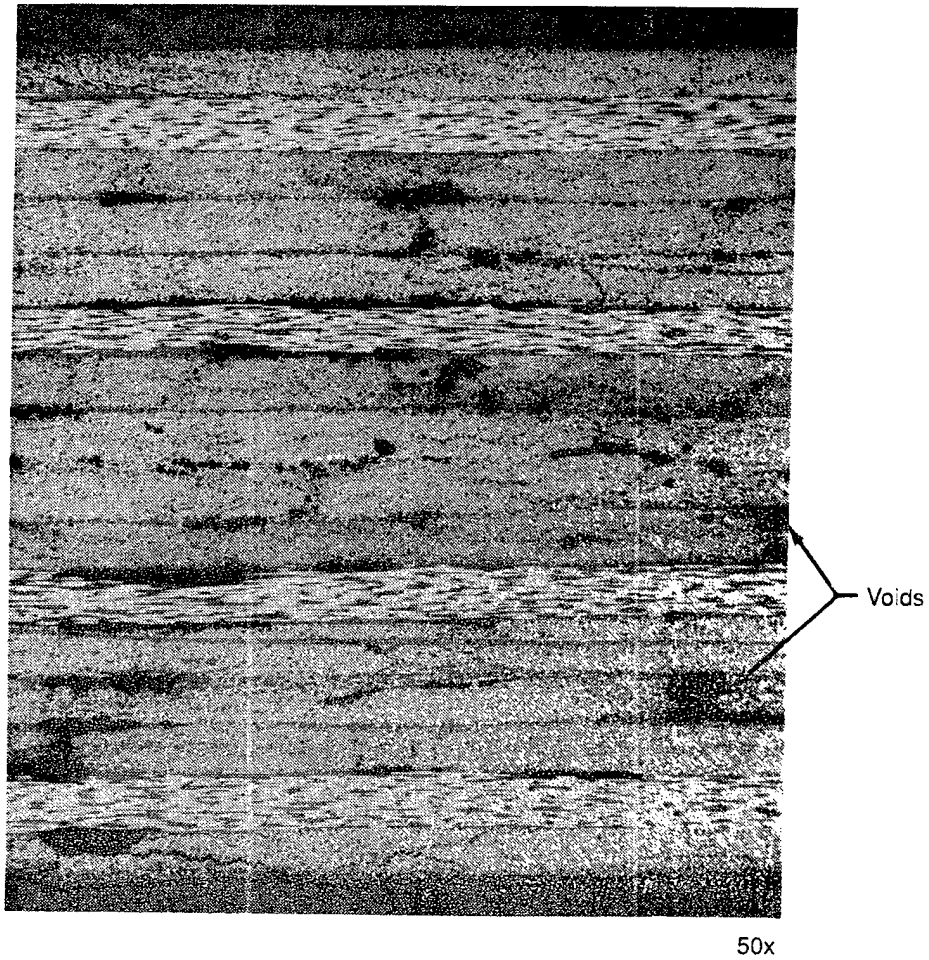
*Figure 15. Cross-Sectional Micrograph of the CFRP Face Sheets
Showing the Extent of Porosity and the Lay-Up Sequence*

A small section of the panel was cut, mounted, ground and polished. The facesheet ply orientation sequence was: [(+45/90/0/-45)2]s. Major voids were observed throughout the facesheet (see Figure 15). This could be the result of incorrect processing of the composite material prior to assembly of the entire component because the adhesive bond appeared to have been processed correctly.

- d. There was a uniform distribution of voids or porosity throughout the CFRP face sheets.
- e. Damage to the honeycomb core was either deformation or fracturing. In both cases, the damage only occurred in the center of the cell walls and not at the core-adhesive region.

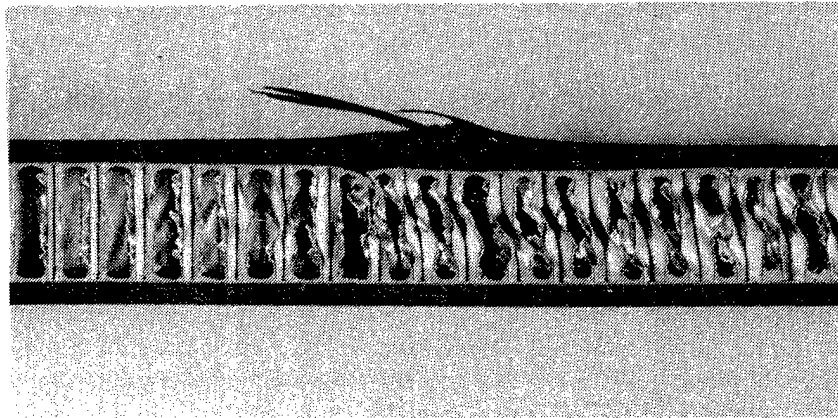
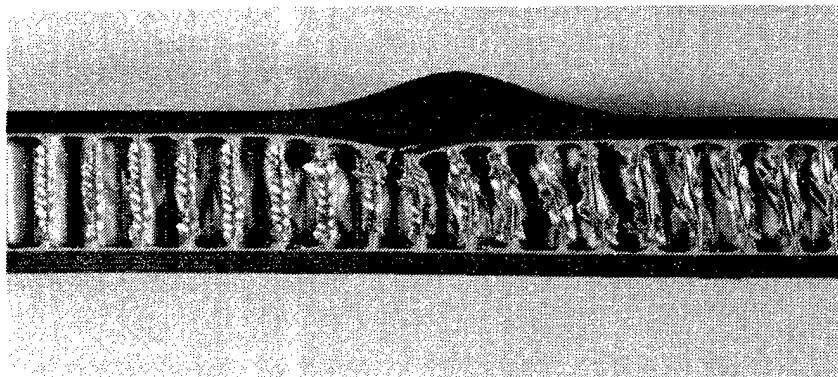
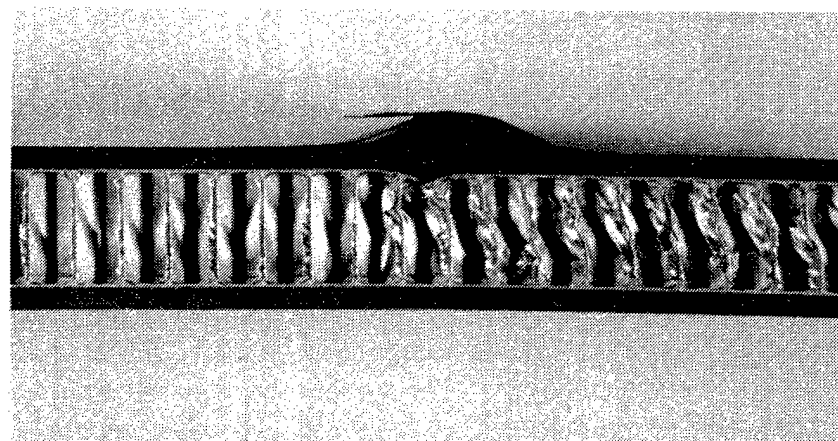
Figure 16. Photographs of Cross Sections Through the Panel Corresponding to the CT Scans:

The component was sectioned longitudinally along the same three locations as the CT scan slices to obtain a more detailed examination of the damage within the panel. Figure 16 shows the cross-section at the right edges of each section which correspond to the CT images in Figures 9 to 11. Examination of the surfaces reveal damage similar to the CT images.

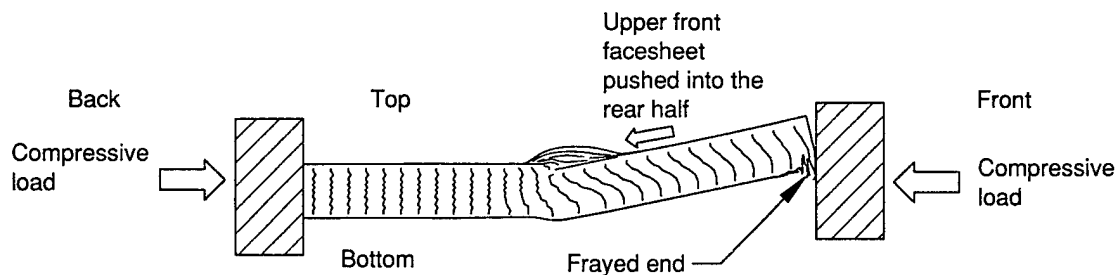
Figure 17. Diagram Showing the Probable Loading Configuration and Subsequent Deformation of the Panel

The transverse delamination region of the facesheets is indicative of compressive loading. There are two general ways in which the panel could have been loaded in order to cause a compressive loaded; the first would be a three point loading configuration; the other would be a simple longitudinal compressive loading applied to the ends of the panel. If the component had been loaded in the three point loading configuration, the bottom side should exhibit tensile cracking and the honeycomb core on either side of the transverse delaminated region would not have been damaged or deformed. However, examination of the internal structure by both the CT scans and the sectioning revealed a non-uniform deformation. The longitudinal compressive loading configuration would most likely have produced this type of damage. Figure 17 shows a diagram of the panel illustrating a plausible loading sequence that could account for the damage to the panel. As the load was applied to both ends of the panel, the top facesheet began to delaminate and eventually buckle. Then the front half of the top facesheet shifted towards the back, deforming the honeycomb core in the process. This in turn caused the panel to bend with the back half of the panel remaining relatively straight while the front half twisted downward which resulted in the edge of the bottom facesheet being frayed. The downward twisting movement also deformed the bottom of the panel.

This description of the fracture sequence assumes that all of the damage to the panel was caused by the simple compressive loading. The porosity in the facesheets was the only anomaly discovered on the panel that wasn't the result of the loading. However these voids did not appear to have influenced the placement of the origins or crack propagation direction, they probably only effected the overall strength of the panel. If there was evidence of damage in the panel prior to the compression loading, it would have been destroyed by the subsequent loading.

- f. Based on the information collected from the examination, the damage most likely occurred as a result of longitudinal compressive loading.
- g. Other than the porosity, no other anomalies were identified that could have caused premature failure or crack initiation.

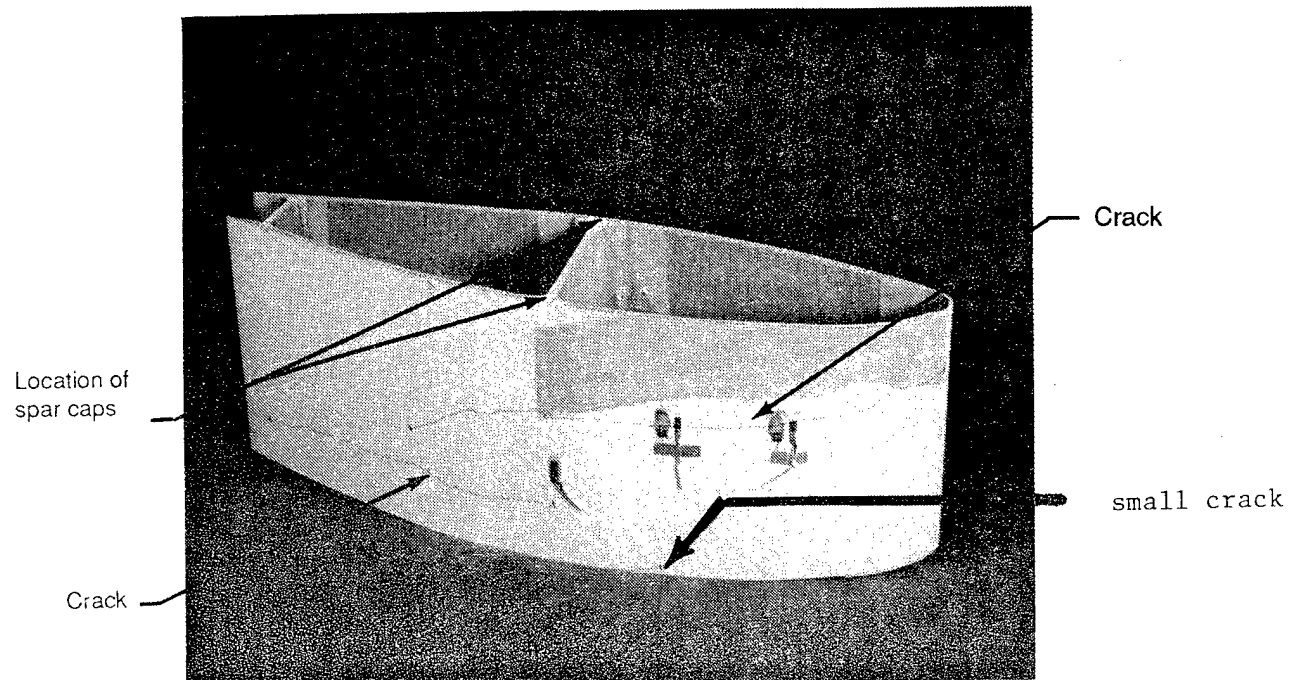
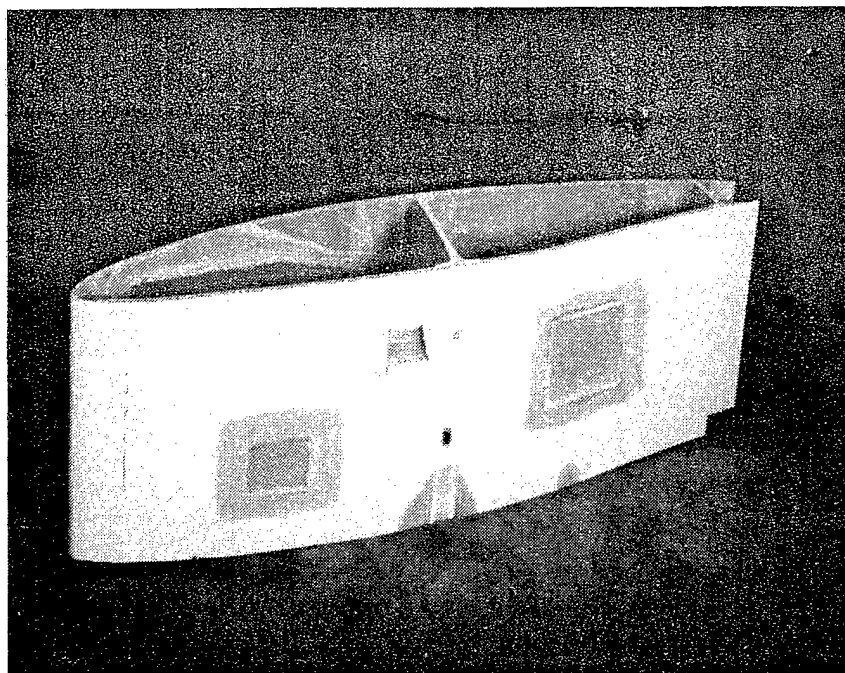
Figure 2. Photographs of the Outer Surfaces of the Wing Section
 a) Upper Surface
 b) Lower Surface

Outer Wing Surface - The upper wing skin was composed of a paper honeycomb core with layers of fiberglass plies on both sides. White Gelcoat was present on the outer surfaces. The upper skin contained two long cracks and one small crack. One long crack extended approximately three quarters of the way from the leading edge towards the aft. The other long crack was located between the mid spar and the aft spar. The small crack was located on the edge of the wing section near the middle of the wing section. In addition to the cracks; a large section of the surface, located adjacent to one edge and between the leading edge and the mid spar, had been sanded through the gelcoat.

The lower skin, fabricated identically to the upper skin, contained five regions which appeared to be in various stages of repair. Two of the regions (one ~5.5 and the other ~3.0 inch square) were located in the main section of the lower skin. Both contained exposed honeycomb and white potting compound along the perimeter of the exposed regions. In addition, the surfaces adjacent to these two regions were sanded. Another region (~2.0 inch square) simply had the honeycomb removed down to the inner surface skin. Finally, two sanded regions were located on the edge of the lower skin, one at the spar cap and the other aft of the mid-spar. Both of these regions were approximately 2 inch square and had also been sanded through the Gelcoat.
